# Inspection Report

**Property Address:**  
985 Battle Front Trail  
Farragut, TN 37934

**HomeTek Residential Inspection Services**

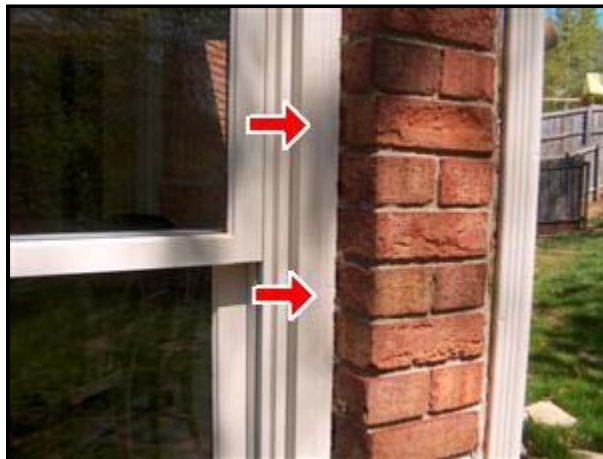
2.2 Picture 1

**2.2** The wood trim is peeling paint at most windows. Further deterioration may occur if not repaired. I recommend a qualified contractor inspect and repair as needed.

The wood trim is peeling paint at most windows. Further deterioration may occur if not repaired. I recommend a qualified contractor inspect and repair as needed.

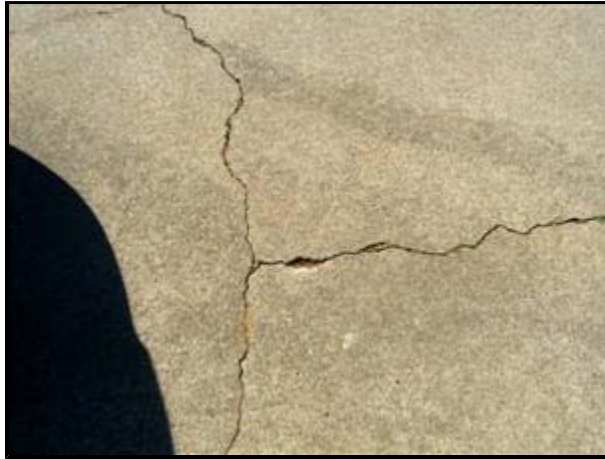
2.4 Picture 1

**2.4 (1)** The concrete drive at the left side (facing front) has settlement cracks. This is considered typical.

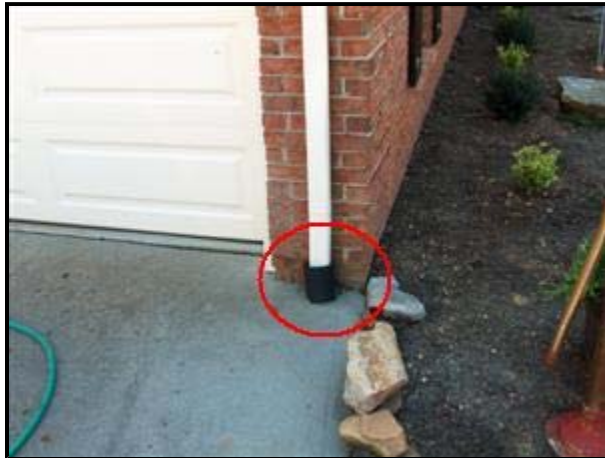
2.4 Picture 2

(2) I recommend that drainage systems be checked to insure proper water drainage. These tubes tend to get clogged over time with dirt, roots, etc.

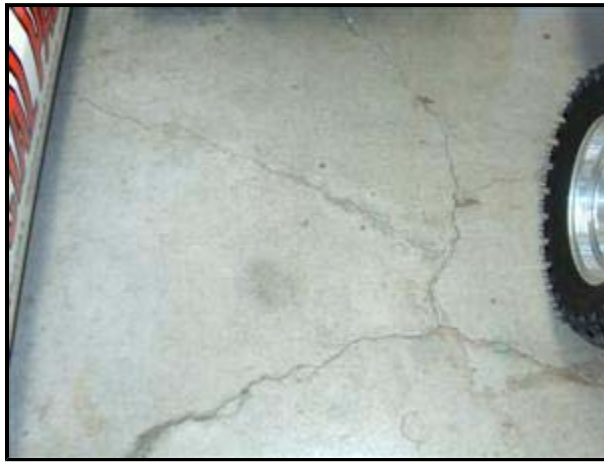
3.2 Picture 1

**3.2** The concrete floor of garage is cracked in areas. These cracks do not appear significant and seem typical. .

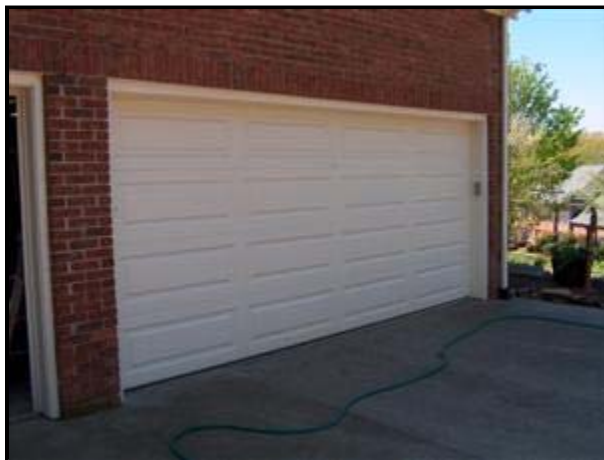
3.3 Picture 1

**3.3** The two-door garage at the left side (facing front) will not reverse when met with resistance. This is considered unsafe and needs correcting. A qualified person should repair or replace as needed.

The two-door garage at the left side (facing front) will not reverse when met with resistance. This is considered unsafe and needs correcting. A qualified person should repair or replace as needed.

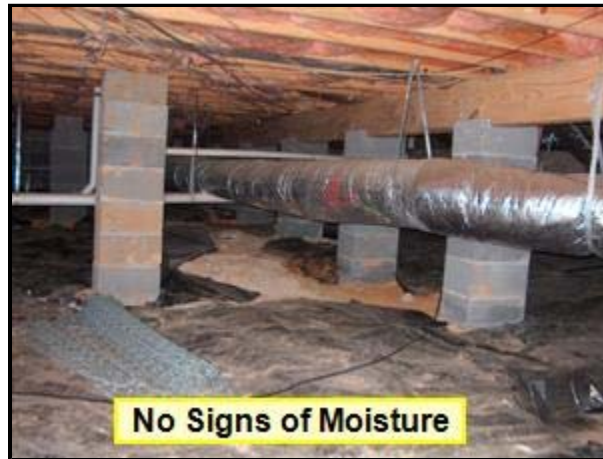
5.0 Picture 1

5.0 The crawlspace showed no signs of water intrusion and appeared to be dry.

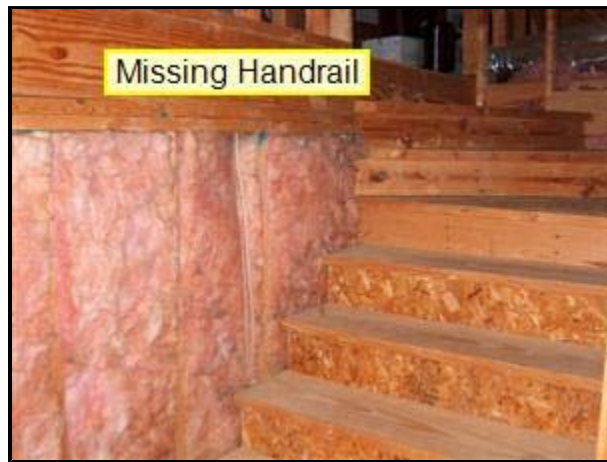
5.5 Picture 1

5.5 Attic stair case did not have a handrail. I recommend adding a handrail as this is a safety issue.

Attic stair case did not have a handrail. I recommend adding a handrail as this is a safety issue.

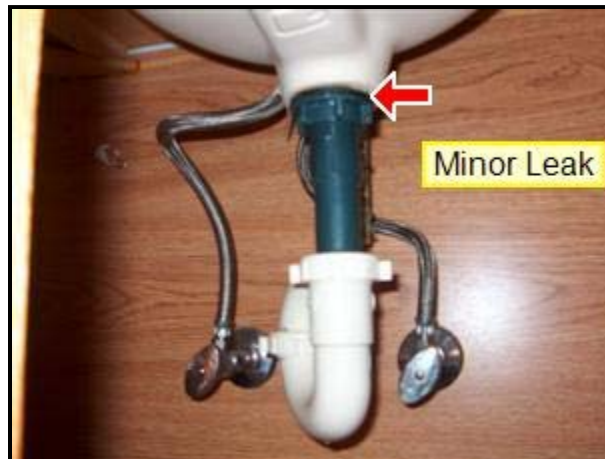
6.1 Picture 1

**6.1** The sink in upstairs rear bathroom has a minor leak in the drain. I recommend a qualified person repair before using.

The sink in upstairs rear bathroom has a minor leak in the drain. I recommend a qualified person repair before using.

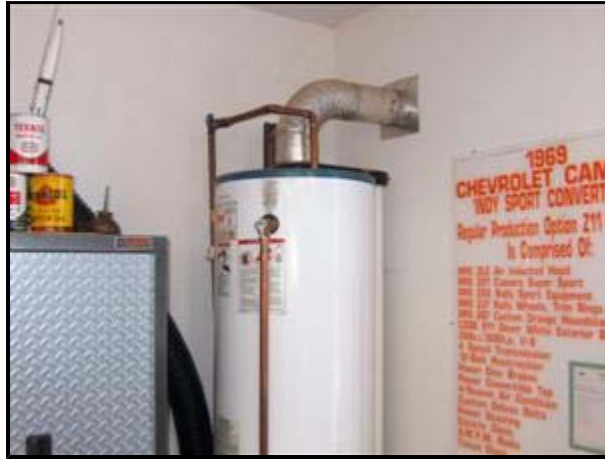
6.2 Picture 1

**6.2** The water heater is located in the garage. It is a Rheem brand and appears to be the original gas water heater. It was operating properly at the time of inspection.

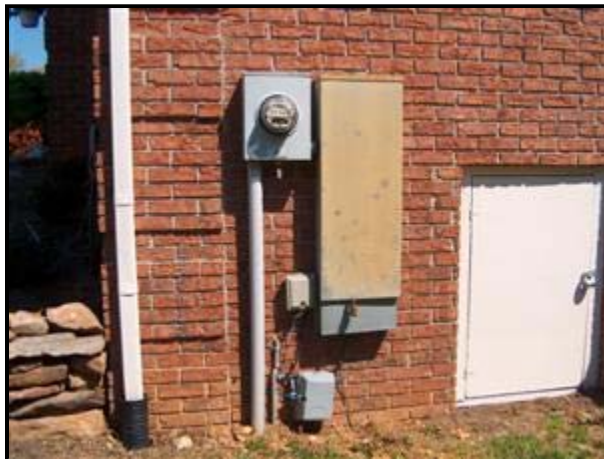
7.6 Picture 1

**7.6** The main panel box is located on the right side of house on the exterior.
